## **INSPECTION REPORT**

Pre-Shipment Inspection (SAMPLE REPORT)

INSPECTION INFORMATION						
Client	ABCDE	BCDE				
Supplier	ABCDE	BCDE				
Factory	ABCDE					
Inspection Instruction	MSTP-M-004-M7	1STP-M-004-M7				
P.O. No.	123456, 123456	P.O. Quantity	999 Pieces			
Item No.	Dining Table/Chair	Sampling Plan	ISO2859: Single, Normal			
Inspection Date	XXXXXX	Inspection Level	G-II			
Inspection Sequence	Uploading inspection	Sample Size	100 Pieces			
Inspection Location	XXXXXX	AQL	Critical: 0, Major:2.5, Minor:4.0			
Product Description	Dinning Table

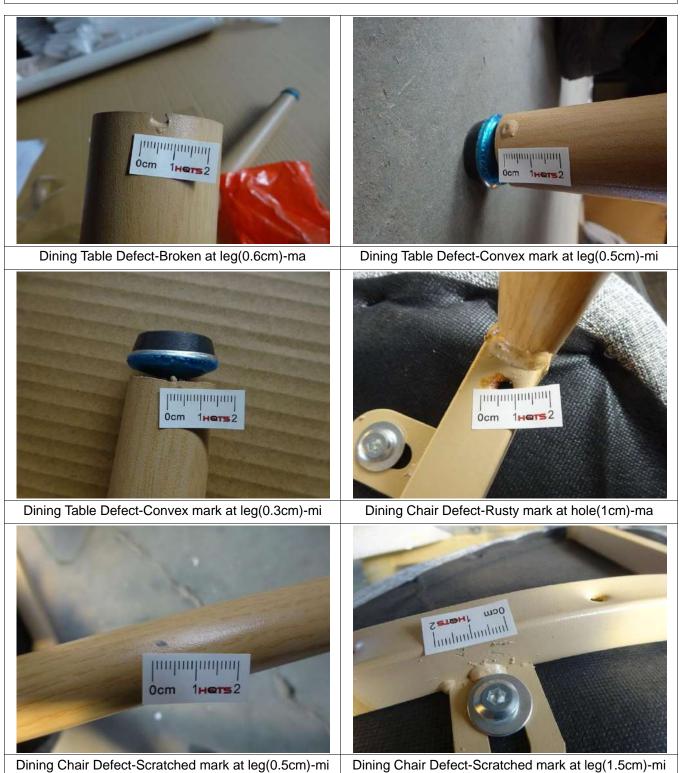
### **Defect Photos**

2.Workmanship				
Defects Description		Critical	Major	Minor
Item#: Dining Table Sample size:11 pieces				
Broken at leg(0.6cm)			1	
Convex mark at leg(0.3~0.5cm)				2
Item#:Dining Chair Sample size:69 pieces				
Rusty mark at hole(1cm)			1	
Scratched mark at leg(0.5~1.5cm)				2
	Total Found:	0	2	4
	Allowed:	0	5	7
	Sample Size:	80	80	80
